APPLICATION NOTE: KODAK USER SETTINGS

The following application note will guide you on how to identify and resolve the error 61 on the Kodak inverters when paired with a Pylontech battery.

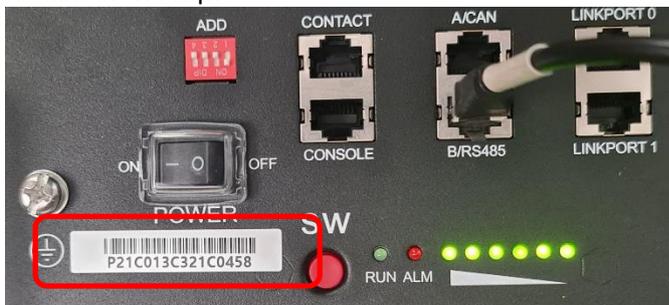
Alternatively, the battery can be identified by the serial number sticker on the front of the battery instead of the top:
